Appendix B
Photograph Log and Photographs

Super Salvage, Inc.
Industrial Stormwater Inspection Report

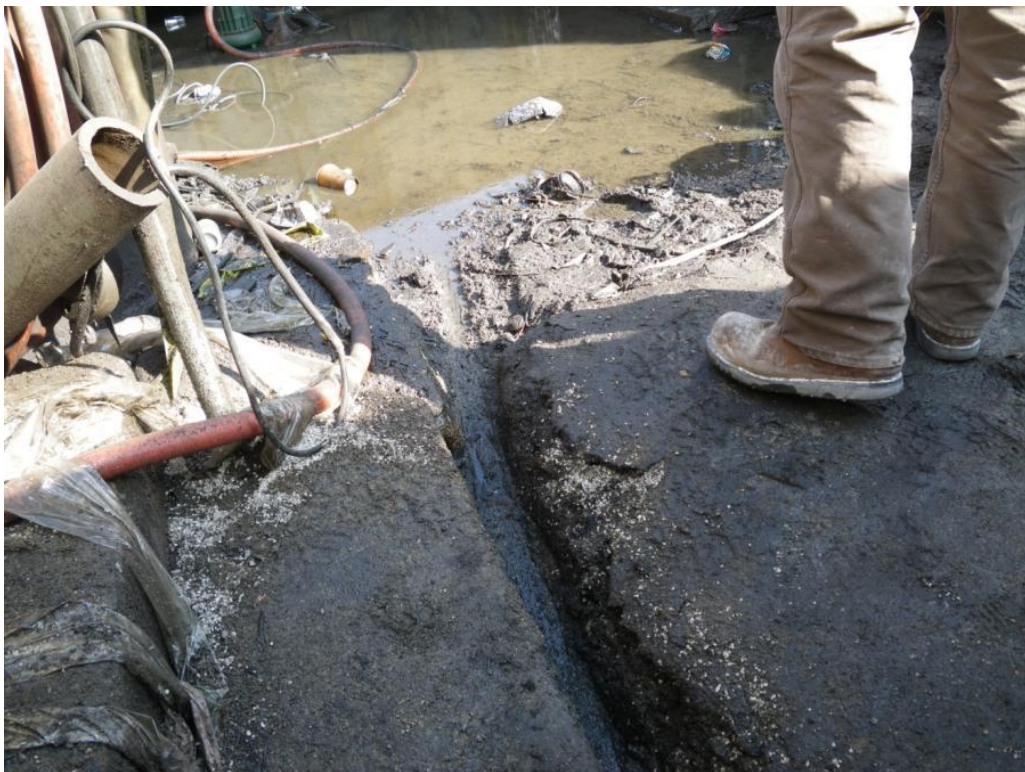
Photograph 30. The end of the trench leading into the small runoff collection pond.

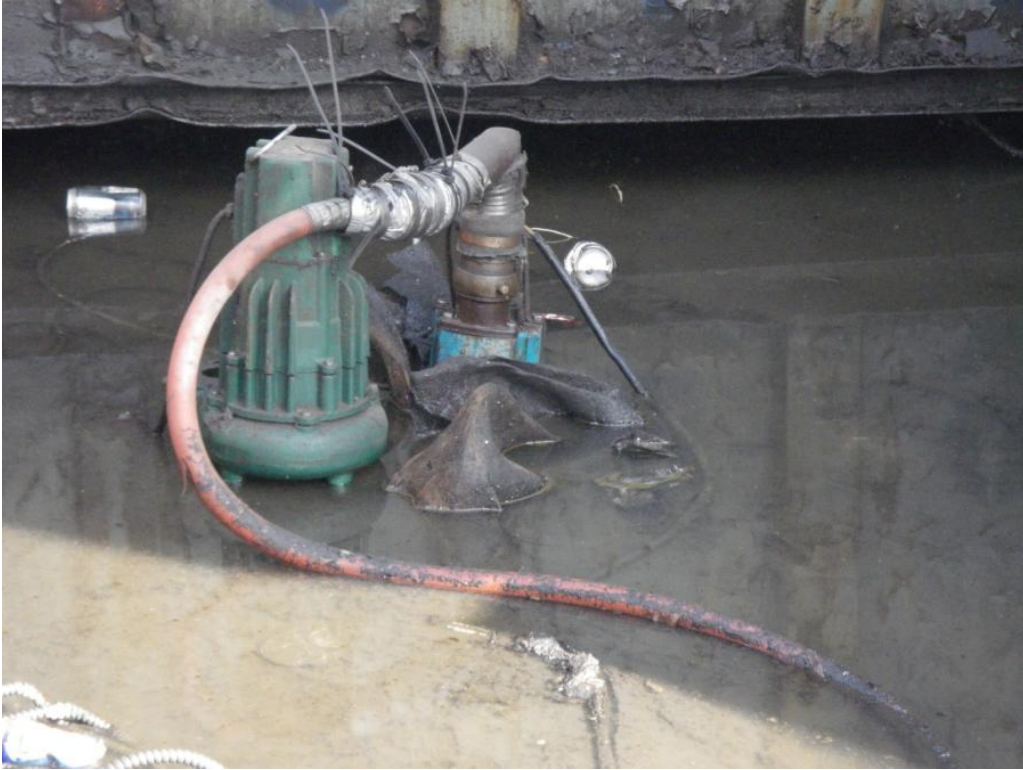
Photograph 31. Close-up view of the manual pump in the small runoff collection pond.

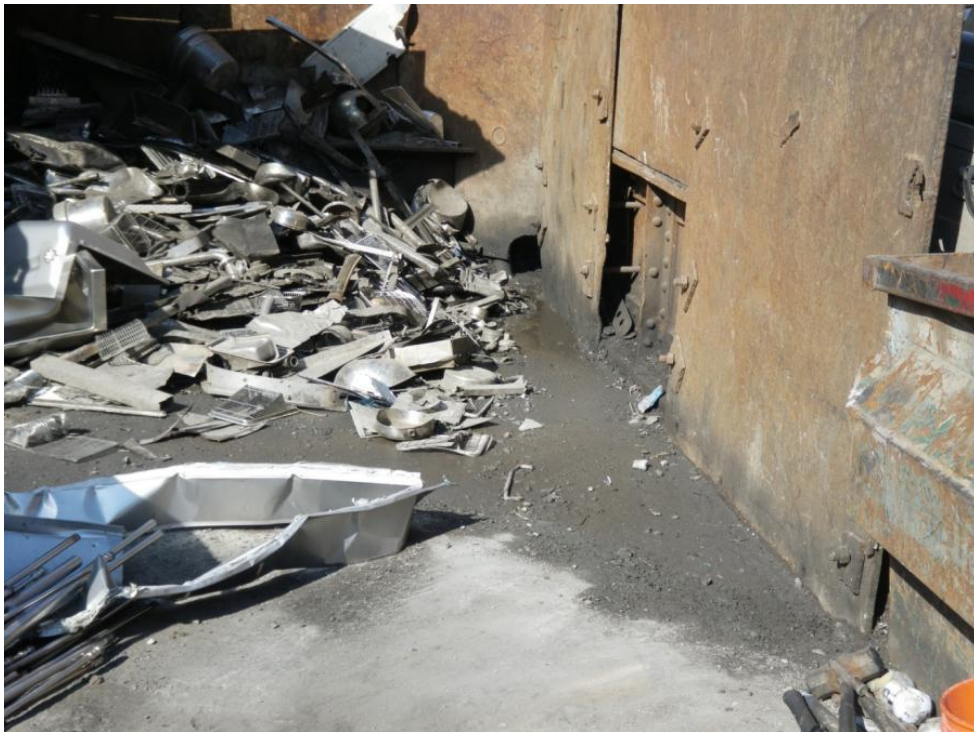
Photograph 32. Alternate view of the entrance to the trench from the opposite side of the wall shown in Photograph 30.

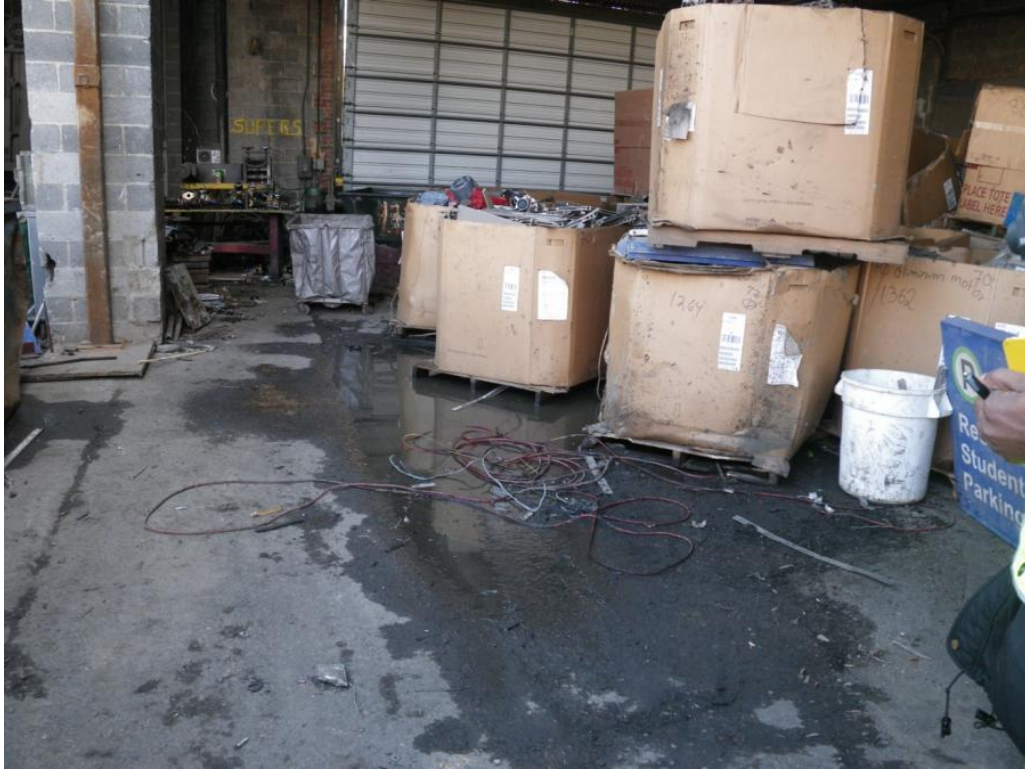
Photograph 33. **Heavy staining on the concrete floors.**

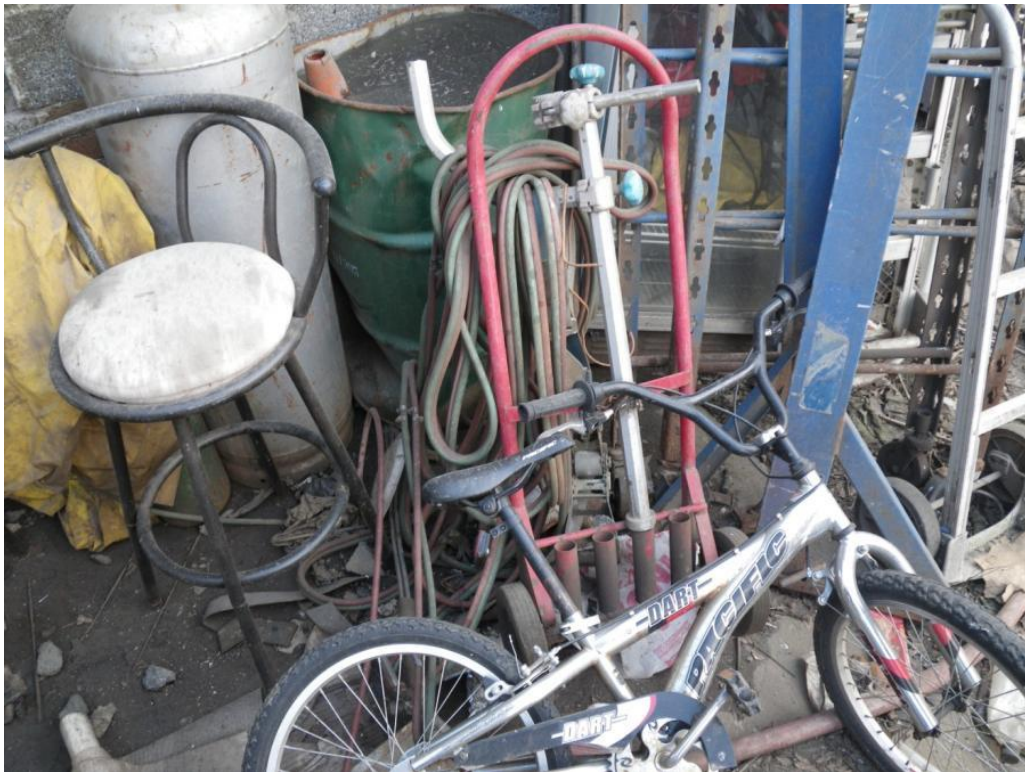
Photograph 34. **Debris adjacent to the large runoff collection pond.**

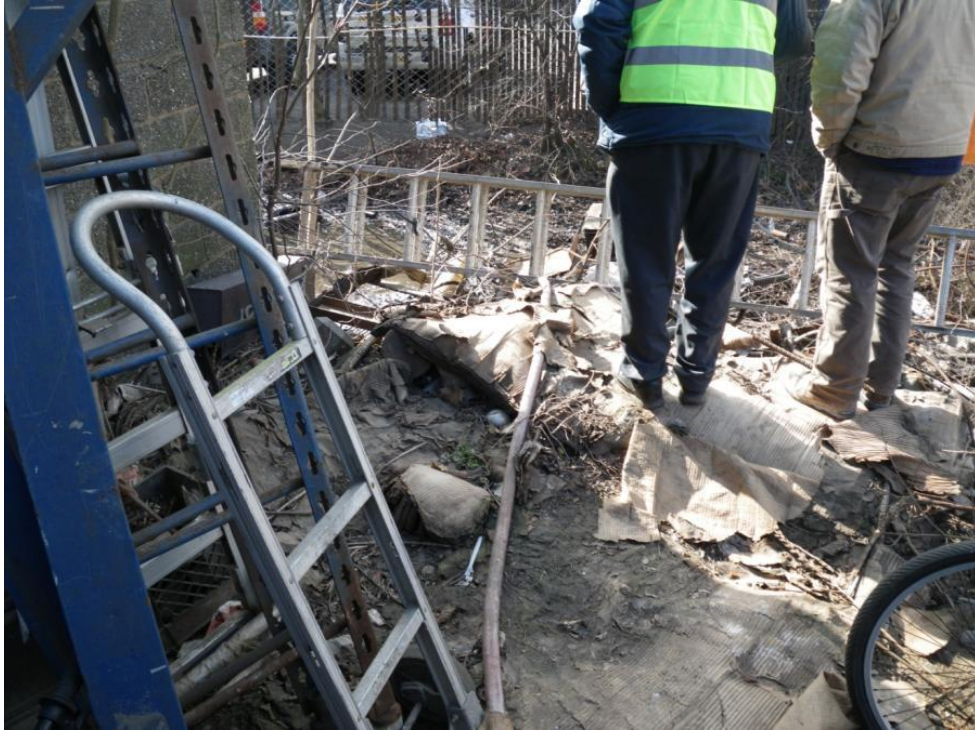
Photograph 35. Red hose leading from the manual pump in the small runoff collection pond to the large runoff collection pond.

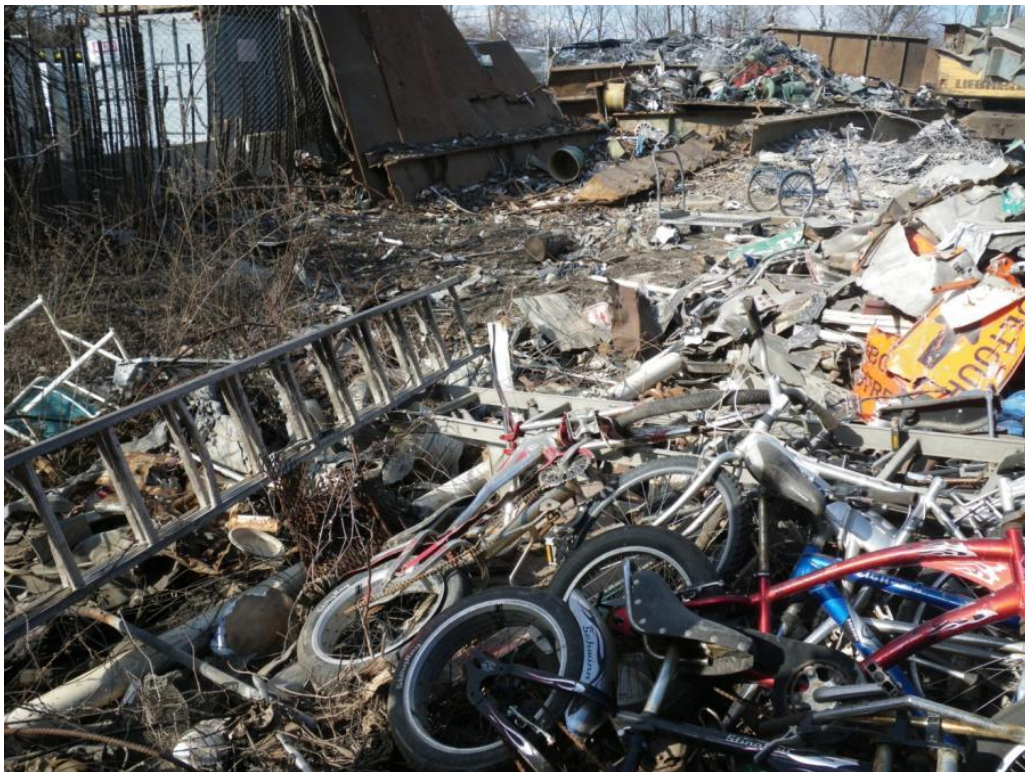
Photograph 36. View of debris just right of the large runoff collection pond.

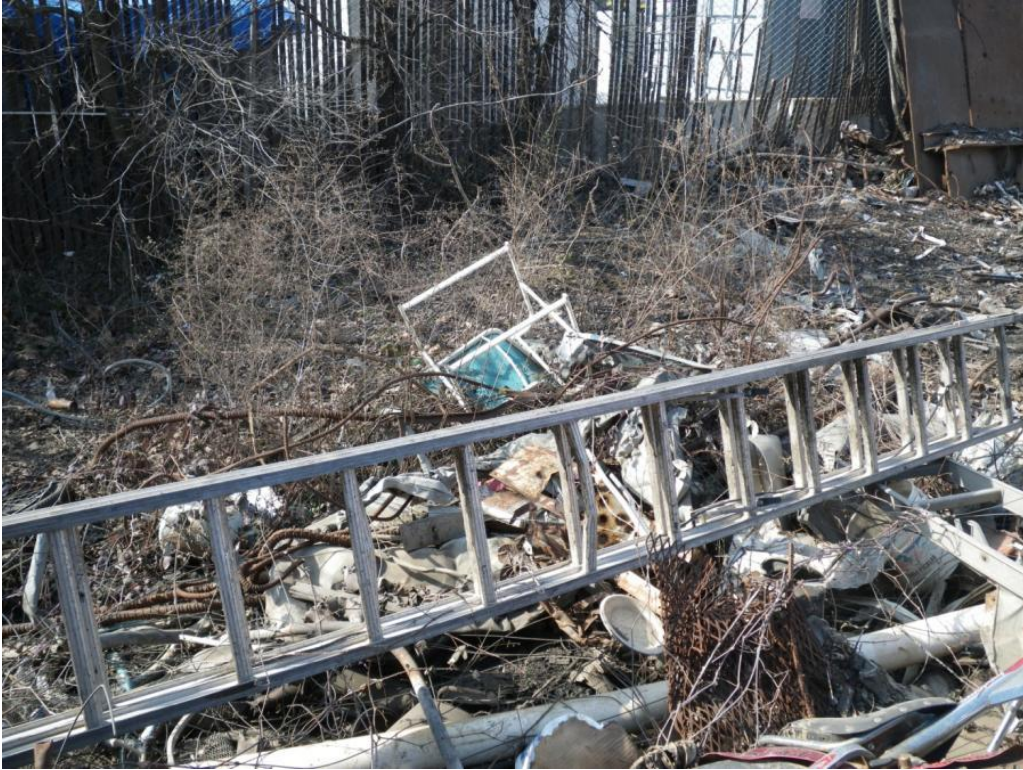
Photograph 37. **Alternate view of debris adjacent to the large runoff collection pond.**

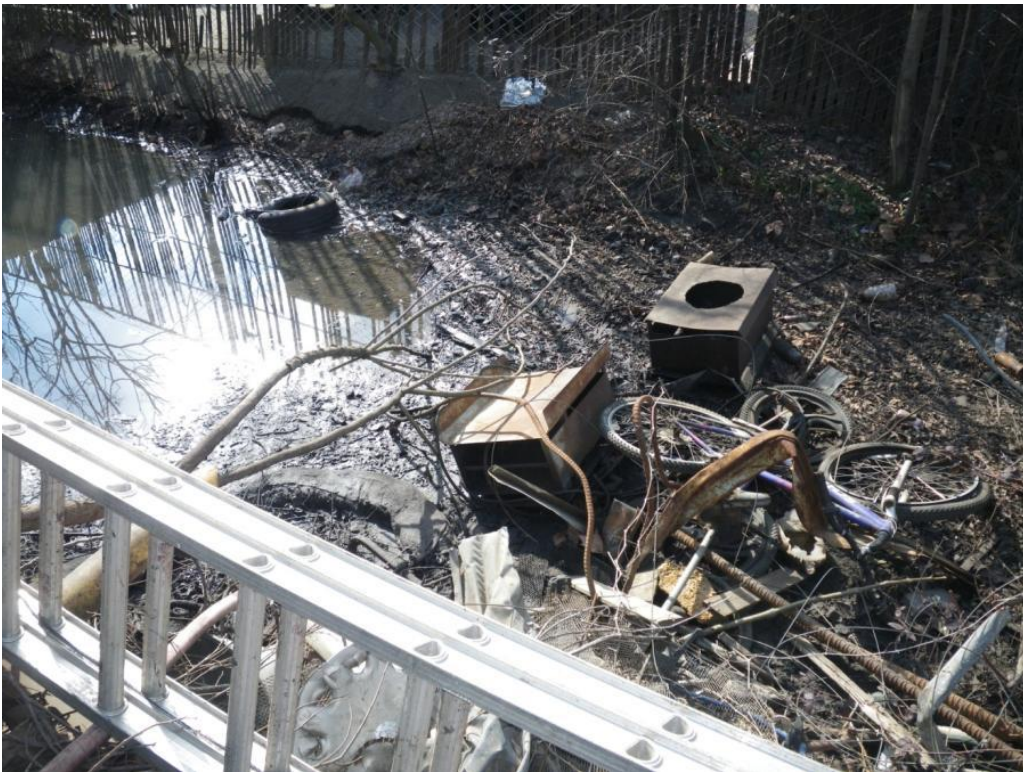
Photograph 38. **Ladder next to the northern end of the large runoff collection pond.**

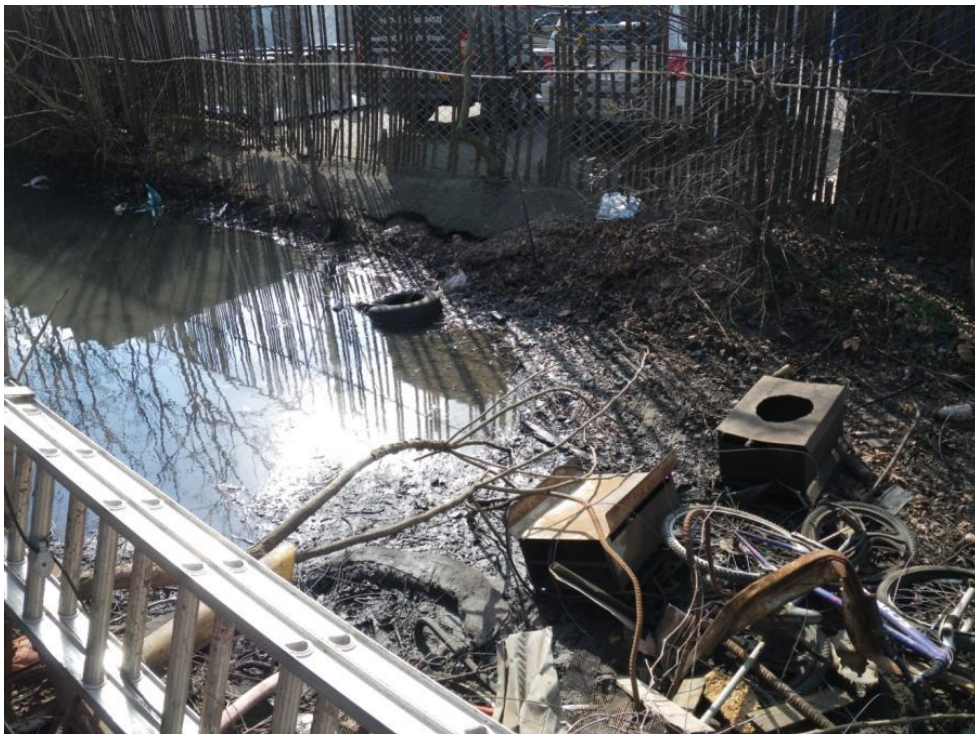
Photograph 40. Alternate view of the absorbent sock relative to the northern end of the large runoff collection pond.

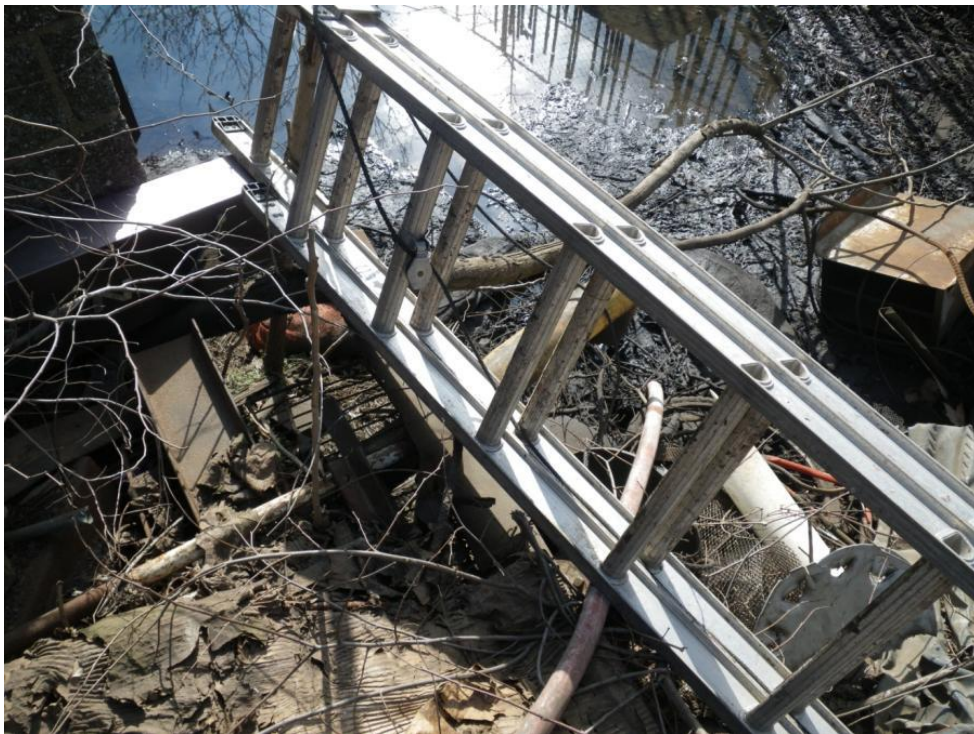
Photograph 42. Alternate view of the absorbent sock at the northern end of the large runoff collection pond.

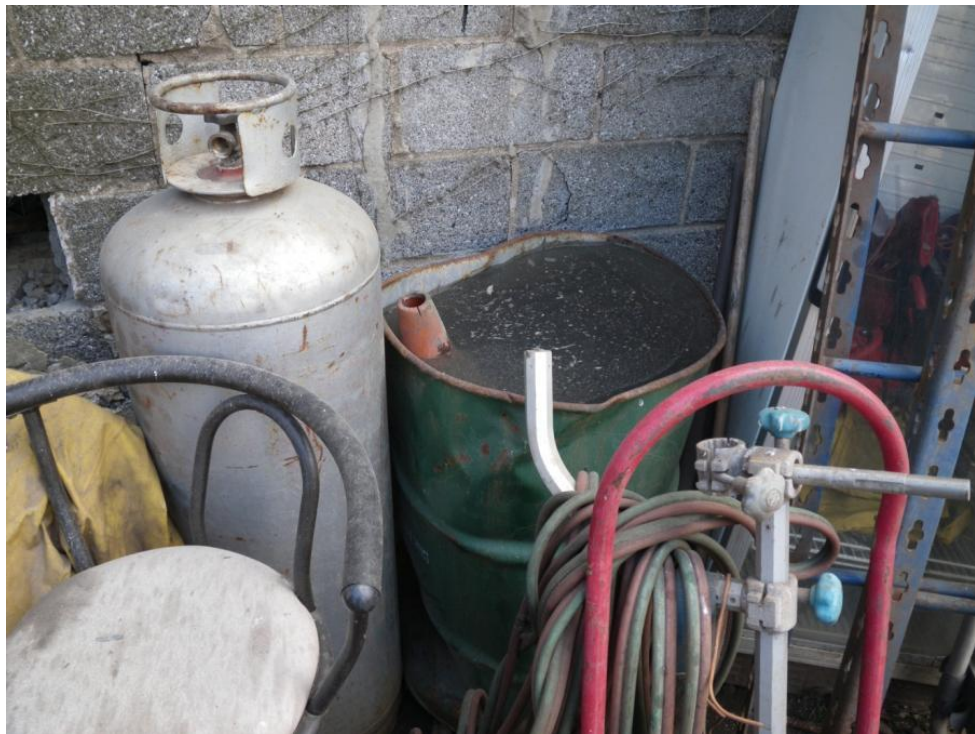
Photograph 44. Close-up view of a drum adjacent to the northern end of the large runoff collection pond. Note the drum is uncovered and containing a gray fluid.

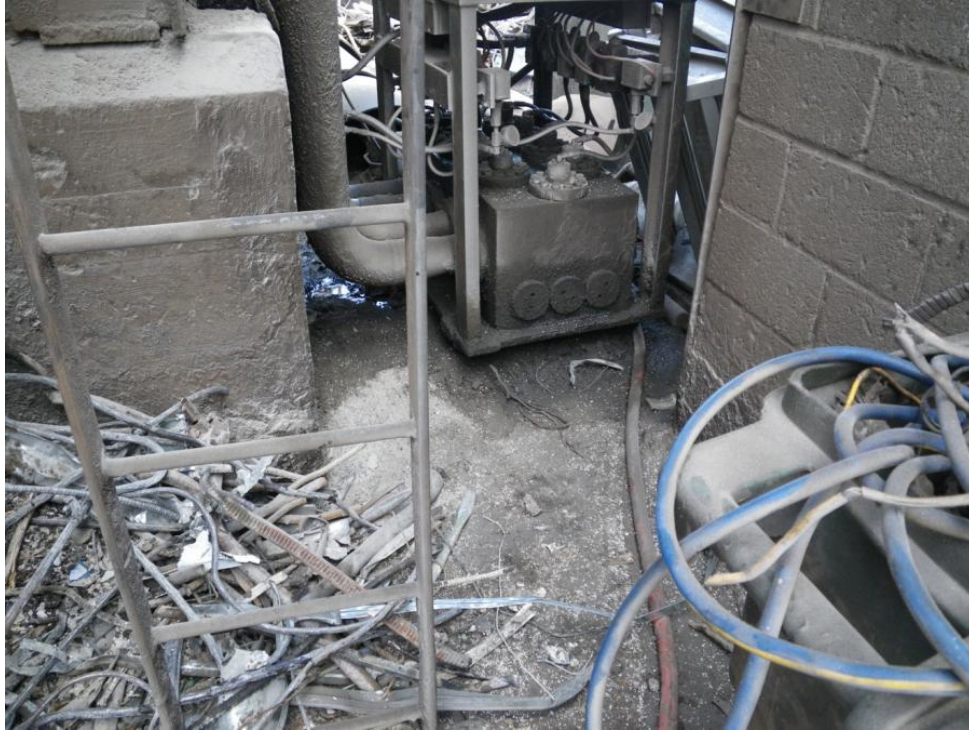
Photograph 45. Fluid leaking from under the conveyor belt of the “crusher”.

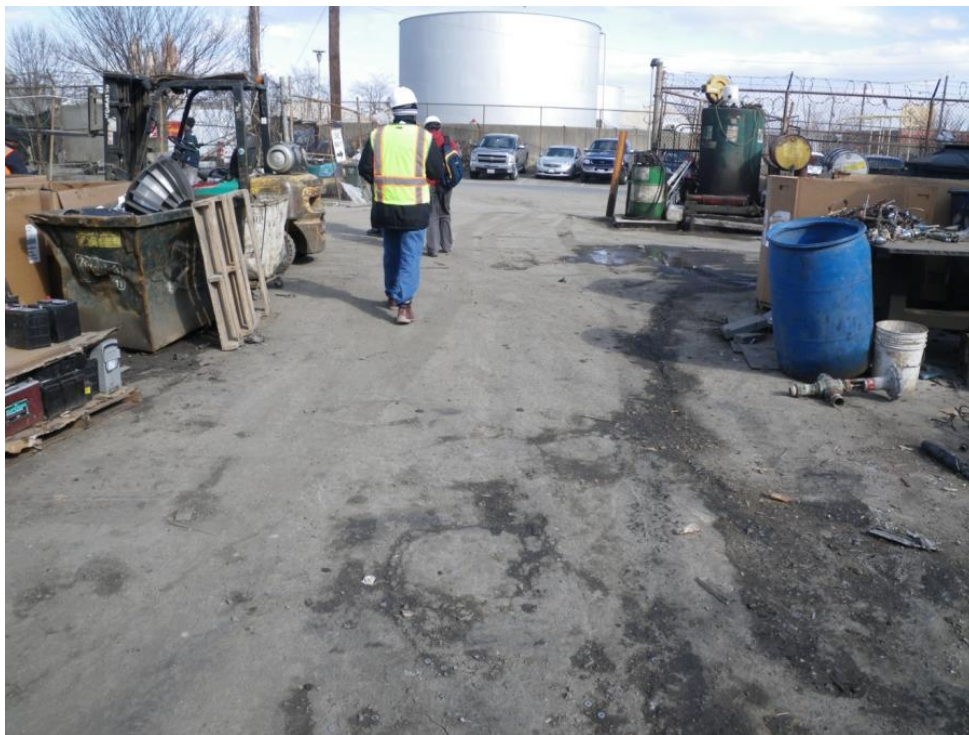
Photograph 46. View of Entrance 1 from the inside the yard showing staining on the ground.

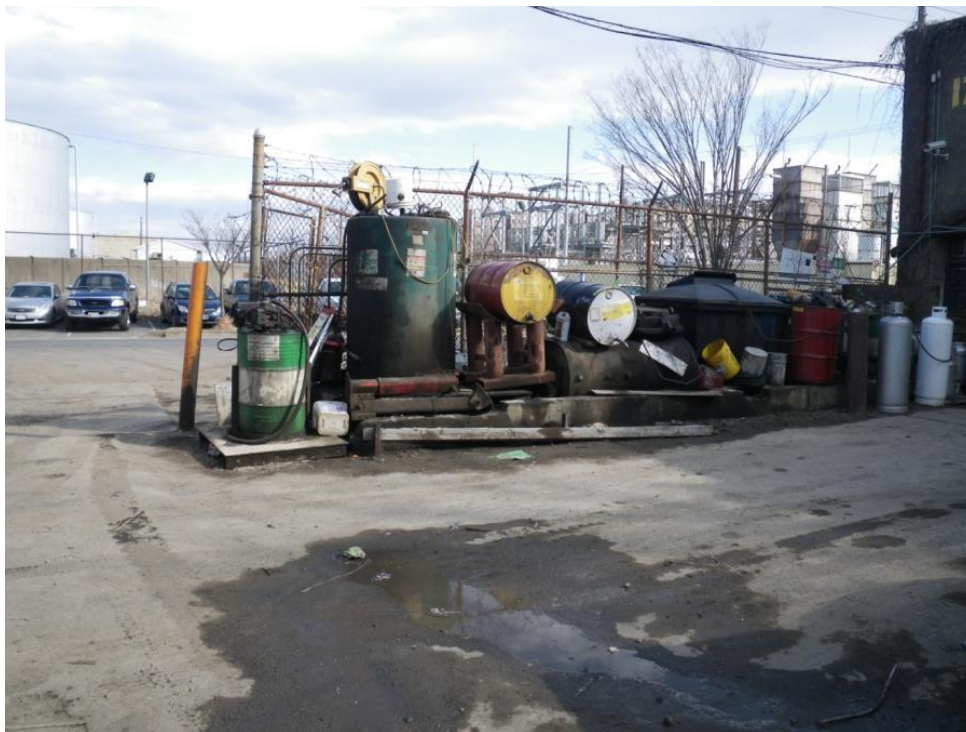
Photograph 47. Overall view of the oil drums stored near Entrance 1.

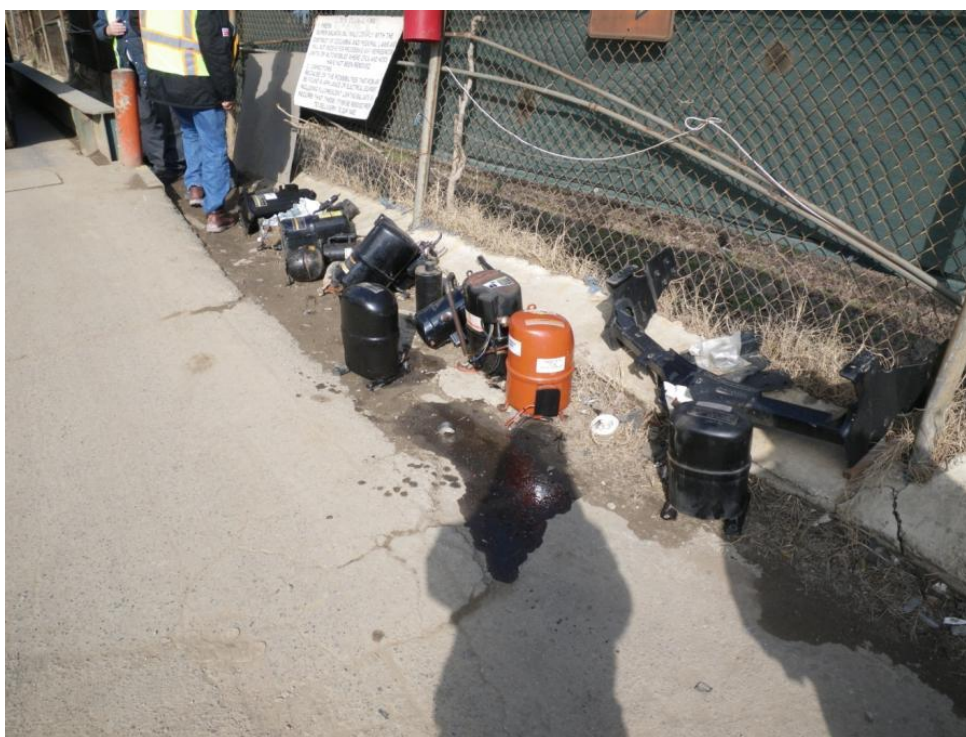
Photograph 48. Air conditioning units, some leaking fluids.

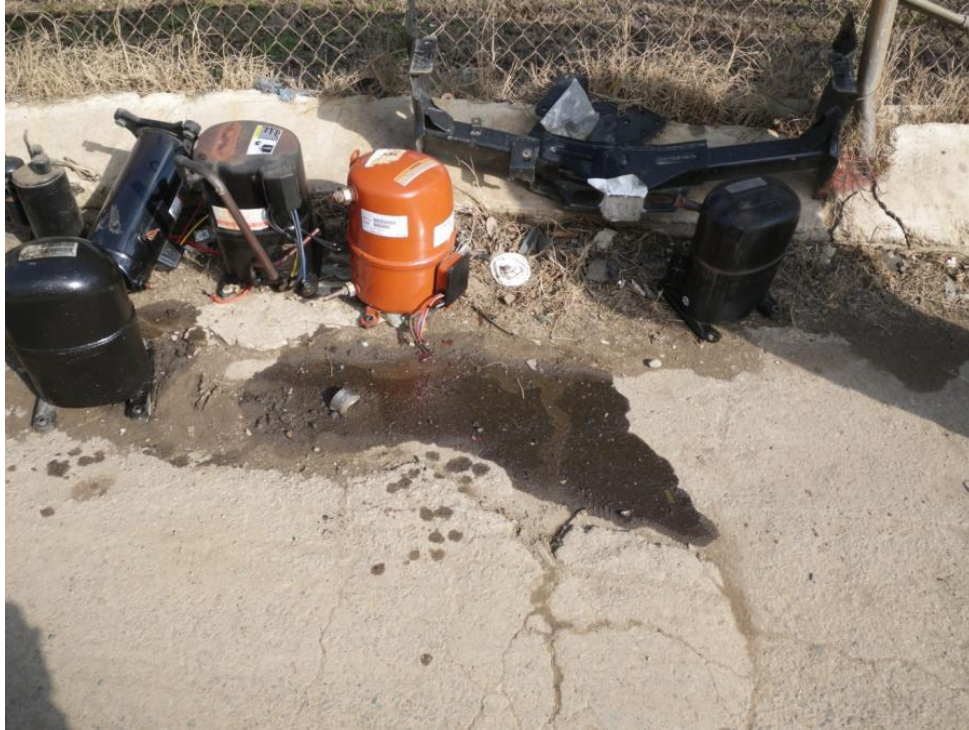
Photograph 49. Close-up view of the air conditioning units from Photograph 48.

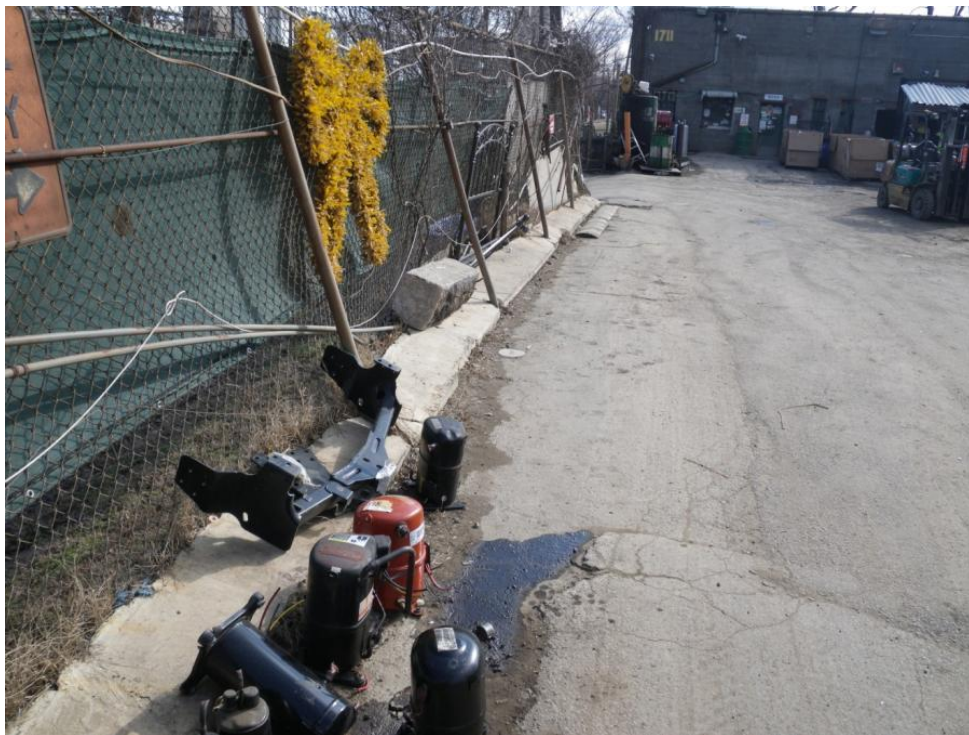
Photograph 50. View of the facility perimeter towards Entrance 1 including air conditioning units from Photograph 48.

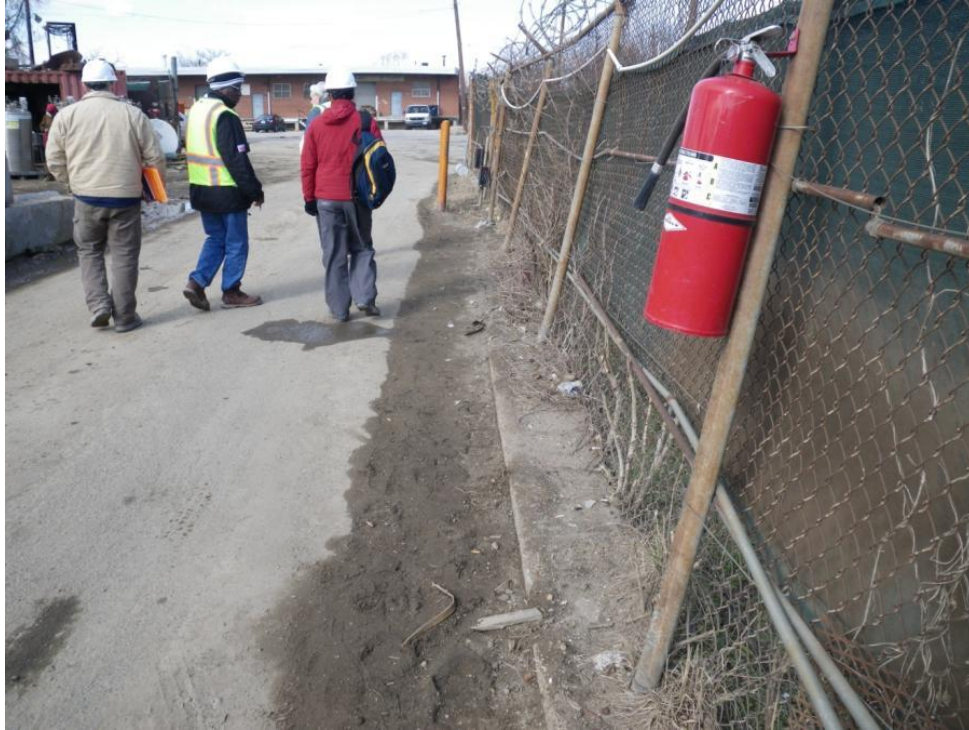
Photograph 51. **Alternate view of the perimeter towards Entrance 2.**

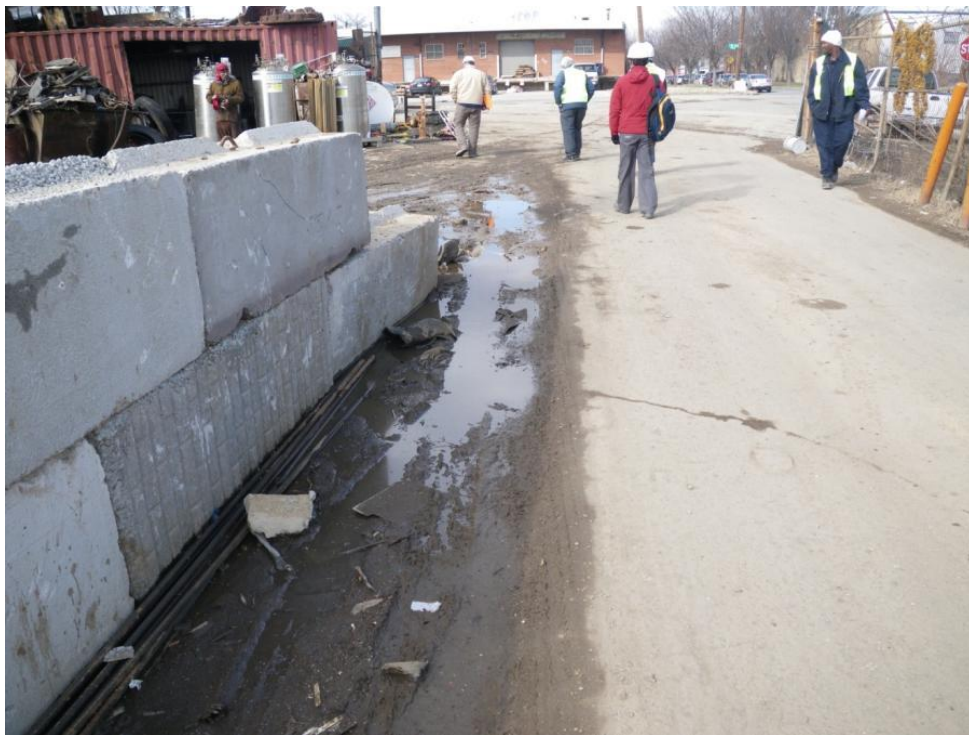
Photograph 52. **Left side of the car path looking north towards Entrance 2.**

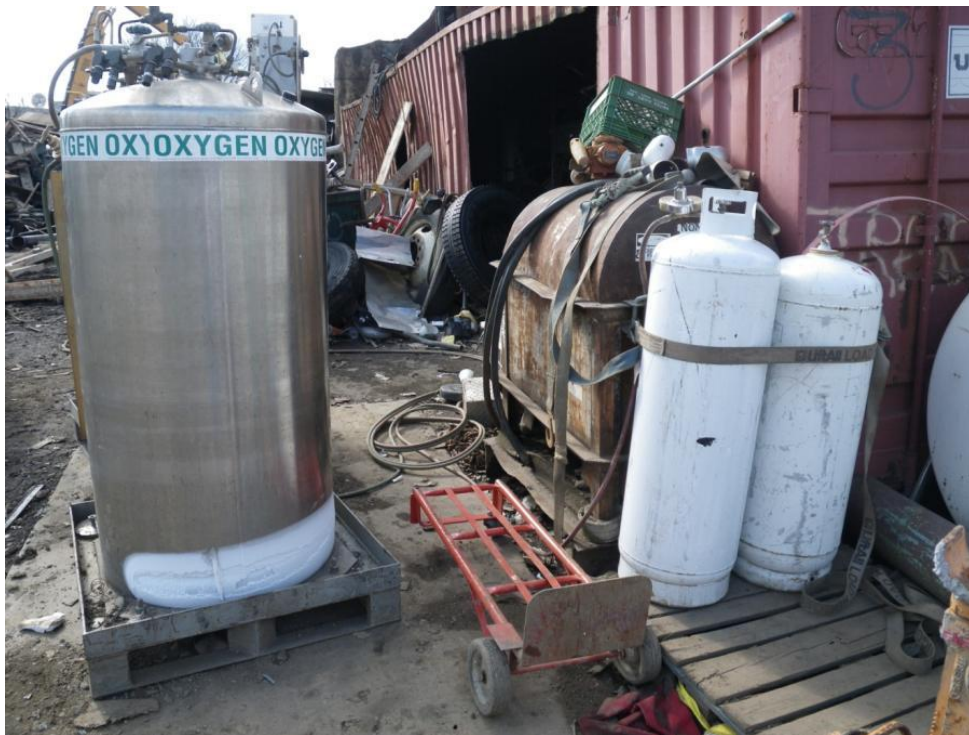
Photograph 54. Compressed gases stored near oxygen tank and fuel used for torches.

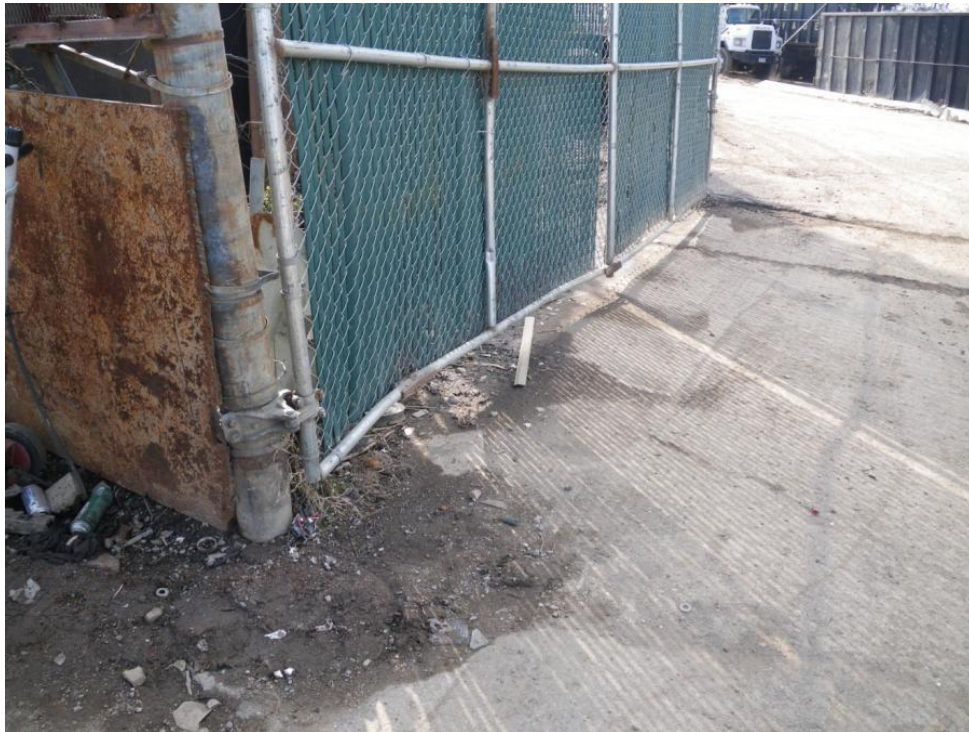
Photograph 56. Staining passing under the property fence onto the District of Columbia (DC) property near Entrance 2.

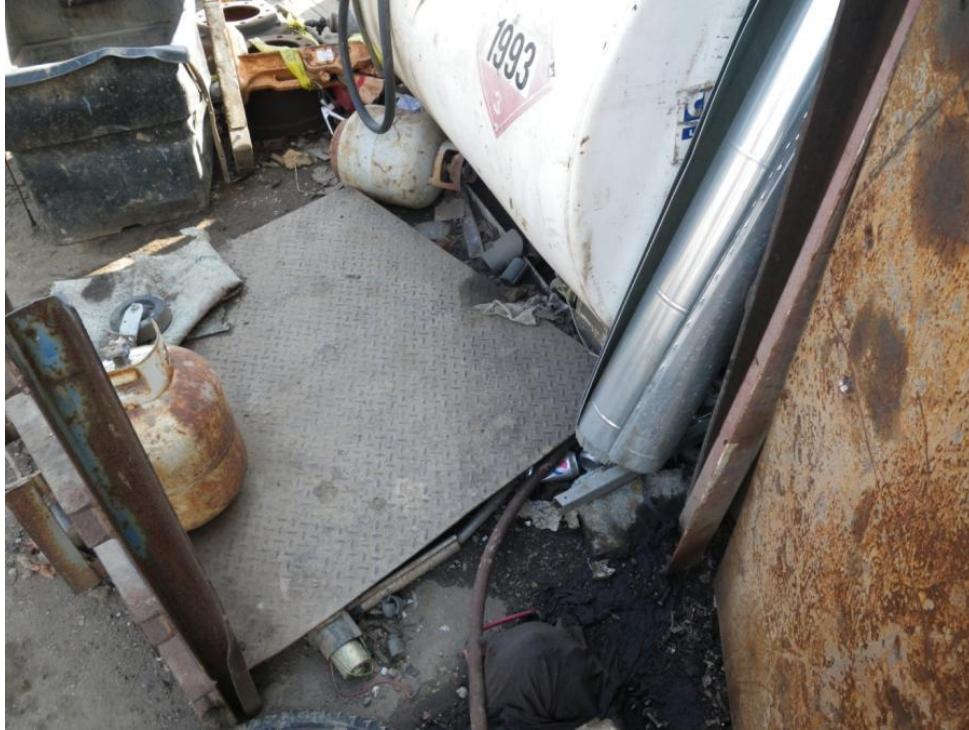
Photograph 57. Scrapped propane tanks stored near 500-gallon fuel tank.

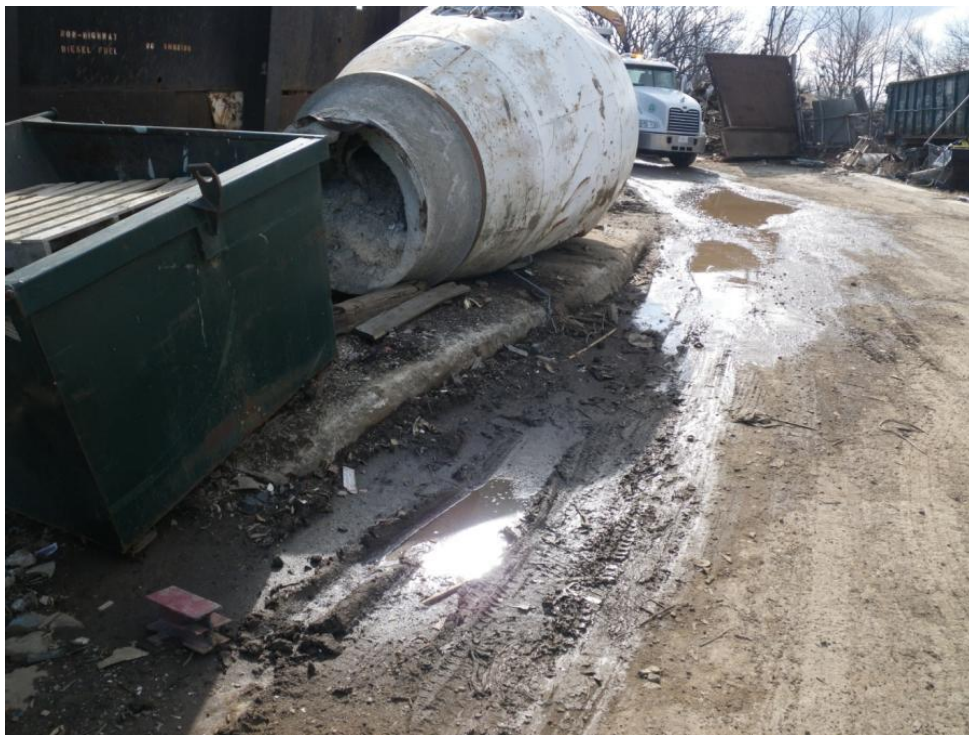
Photograph 58. Storage of debris outside the perimeter of the facility adjacent to the DC property.

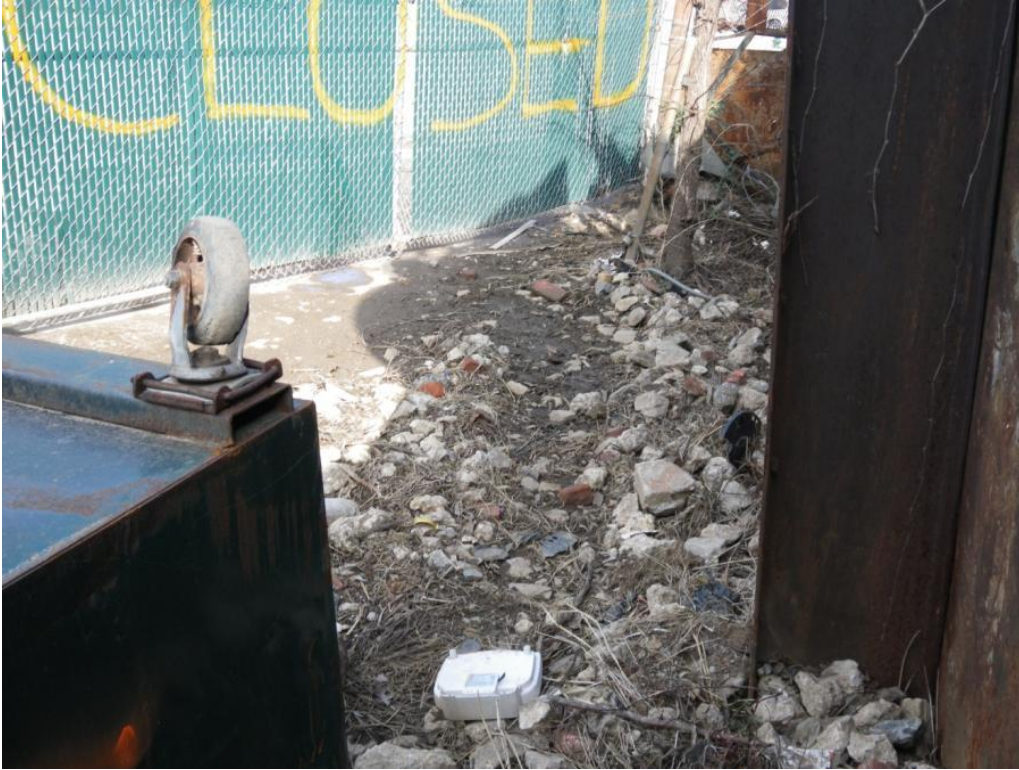
Photograph 59. View of debris around Entrance 2 and staining on the ground.

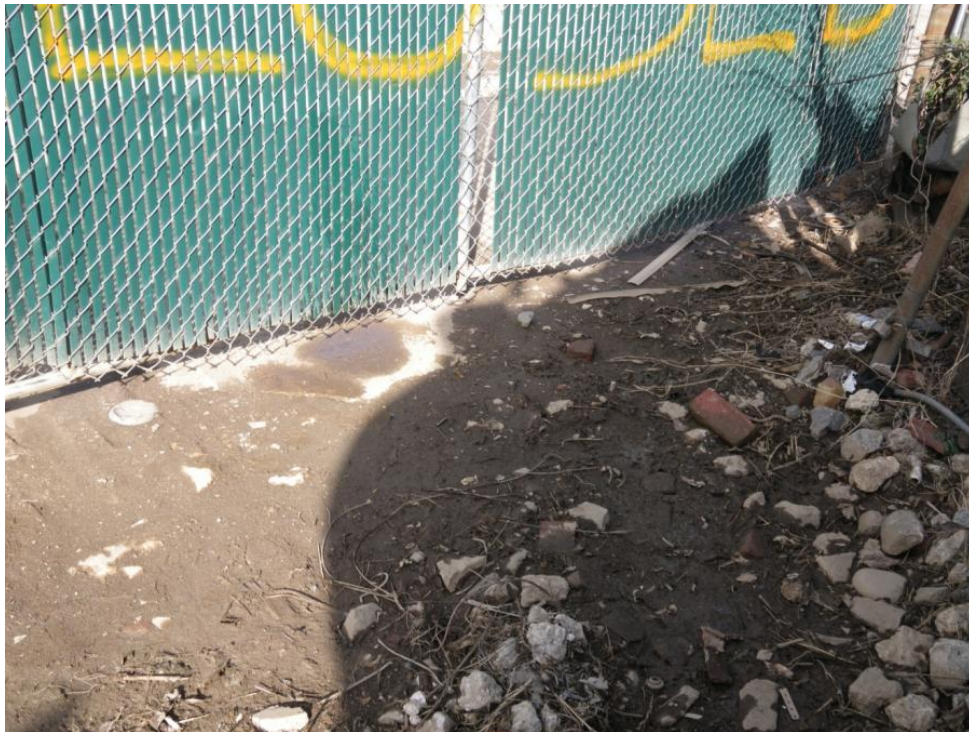
Photograph 60. Alternate view of Entrance 2 to show the staining is not due to shadows.

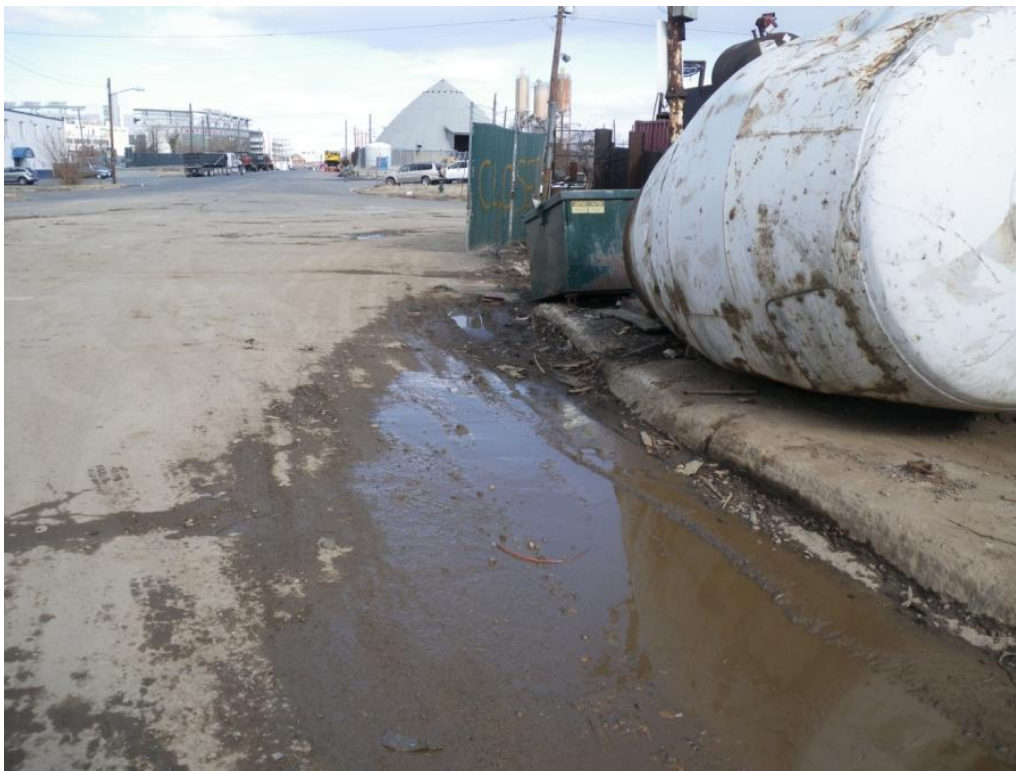
Photograph 61. Sediment residue on streets outside Entrance 2.

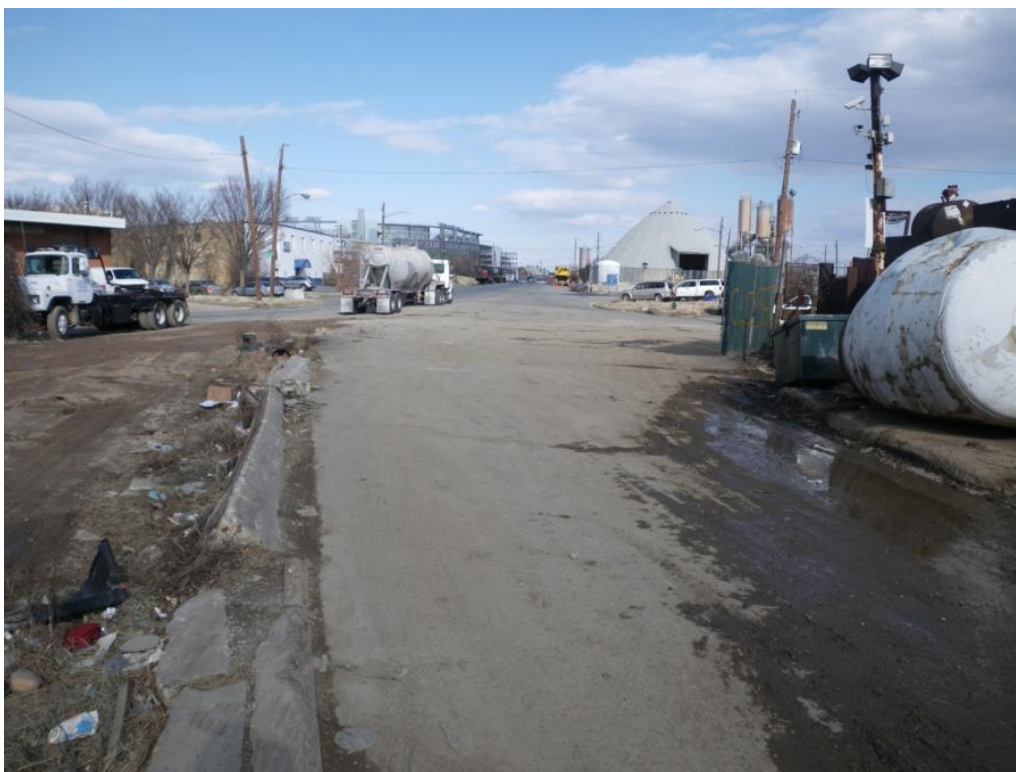
Photograph 62. Alternate view of sediment residue around Entrance 2.

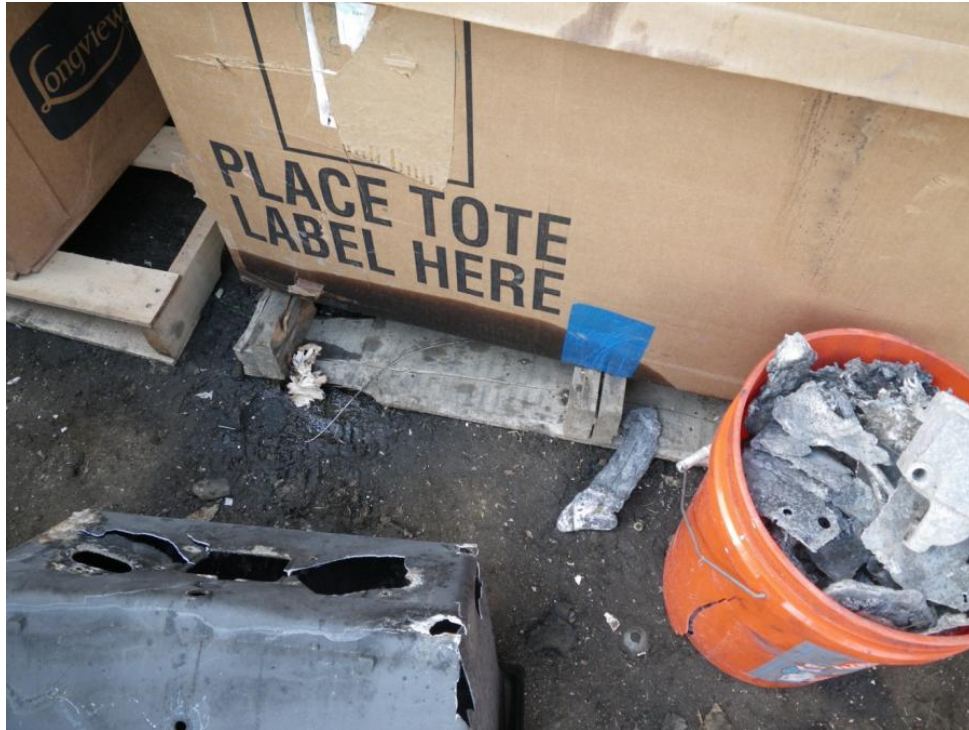
Photograph 65. **Box from Photograph 66 with staining on the outside.**

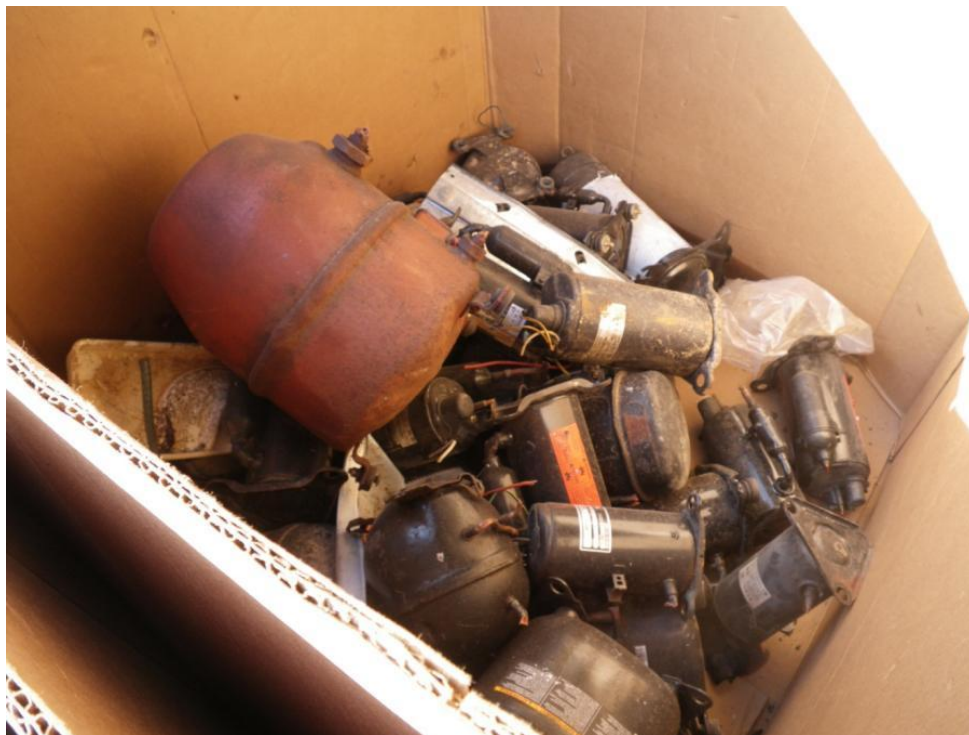
Photograph 66. **View of inside of box with staining shown in Photograph 65. Box contains engine parts.**
